Optical connections

When the patient is a million miles out in deep space, the optometrist needs to get his refraction spot on. **David Baker** explains

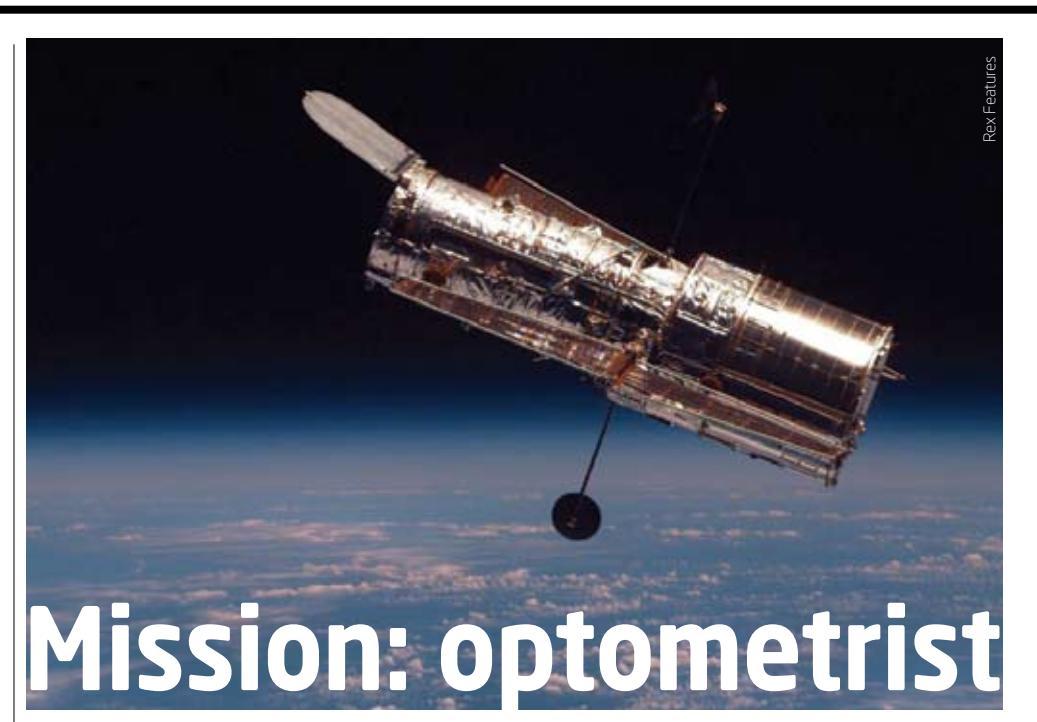
The telescope is a reflector of the Ritchey-Chretien Cassegrain type, which consists of a large, concave, primary mirror that collects light and reflects it to a smaller, convex, secondary mirror. From here the light is reflected back through an aperture in the centre of the primary mirror and focused. HST is designed to house several instruments that can be moved individually into the focal plane of the mirror system. Investigations found the problem to lie with the 2.4m diameter primary mirror, ultimately caused by faulty assembly of the device used to measure its curvature.

This mirror needed to have its reflecting surface ground with a curvature accurate to within 0.032 microns (µm); were the mirror the diameter of the Earth, the curve could deviate from true by only 15cm. Made of ultra-low expansion glass, and kept at a constant temperature of about 21°C to avoid warping, its surface is coated with a 0.076µm layer of pure aluminium covered by a 0.025µm layer of highly UV-reflective magnesium flouoride. The fault in the mirror was determined to be an excess flattening of the peripheral curve of 2.2µm. This may only be one-fiftieth

the thickness of a human hair, but in terms of the accuracy required it was devastating.

By retracing the steps of manufacture of the primary mirror, it was found that the contractor had relied on just a single test to confirm the accuracy of curvature (a mistake NASA learned the hard way not to repeat). This was a cylindrical instrument comprising two mirrors and a lens called a 'null corrector'; through which a laser beam is passed and reflected back from the mirror under test to produce an interferogram - a pattern of black and white lines which allows analysis of the mirror's curve. Unfortunately one of the null corrector's optical elements had been positioned incorrectly by 1.3mm, which then guided technicians to grind the peripheral curve erroneously. It was fortunate indeed that the contractor's null corrector had sat untouched in their plant for 10 years so that, together with the data from HST's fuzzy images, the problem could be traced.

Using all available data, HIORP came up with a 'conic constant' that described accurately the mirror's aberrant shape. New astronomical instruments being developed for HST could then have their optics corrected by, in effect, the inverse of that conic constant to make them compatible with the mirror. But for the three instruments already on board HST, a different solution would be required. A plan was devised to insert a series of coin-sized mirrors, designed to the inverse conic constant, behind the primary mirror on HST. The engineering problems with achieving this in practice were complex, but eventually an assembly of mirrors on mechanical arms which would be unfolded when in situ, the size of a telephone box, was developed. And so the Corrective Optics Space Telescope Axial Replacement (COSTAR) was born.

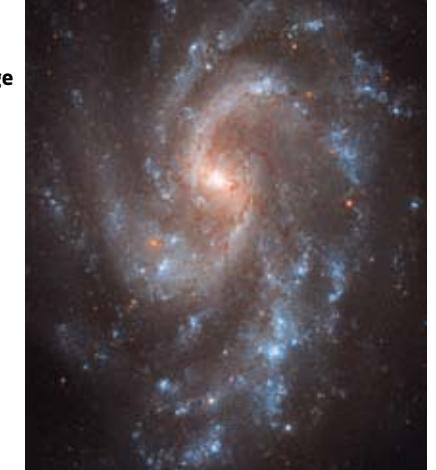
Successful as HST has turned out to be, its replacement is already under construction. In fact, manufacture of the Webb Space Telescope (WST) began in 2004 and is expected to be Hubble enabled astronomers to set the age of the universe at 13.7 billion vears

completed by 2013. This tennis courtsized instrument is an infra-red (IR) telescope designed to detect cooler, more distant objects than HST (which uses visible light) and to be able to penetrate interstellar dust clouds. It will have an 18-segment beryllium parabolic primary mirror 6.5m at its widest part, with a focal length of 131.4m and an optical resolution of 0.07 arc seconds. It will be coated with 24 carat gold, increasing its reflectivity of IR from 85 per cent to 98 per cent and will have an operating temperature of 40K (-233.2C).
